Water Compliance Inspection Report

NPDES Inspection Report

Permit # ID0000175 & IDR053139

Hecla Limited - Lucky Friday Mine

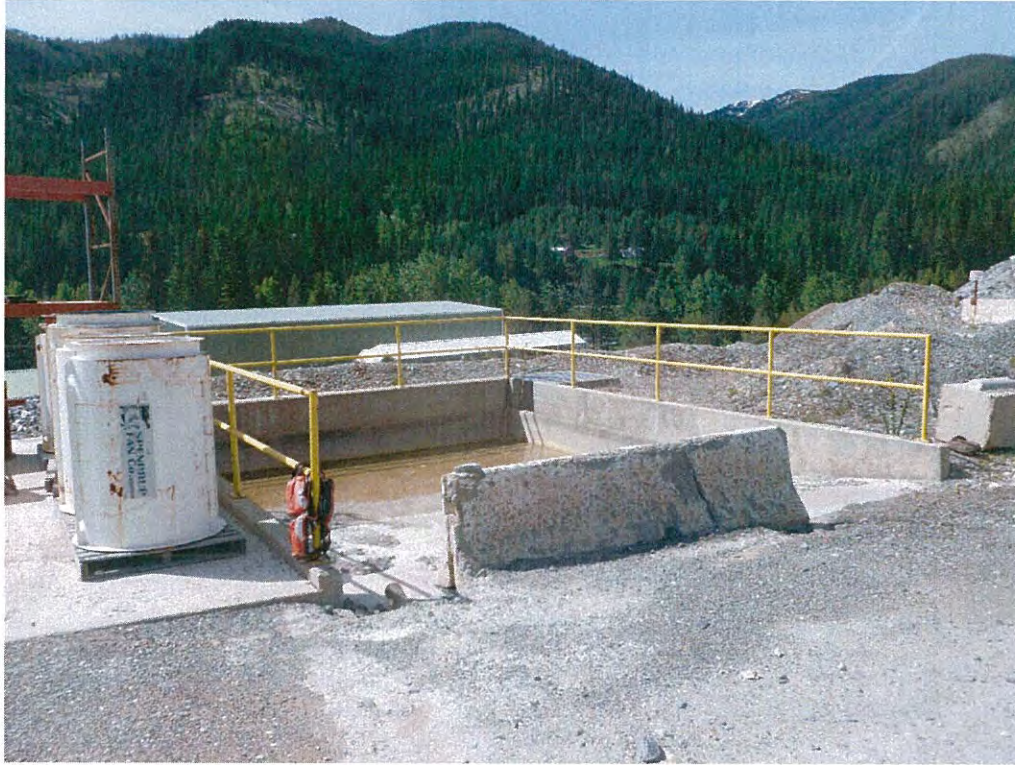
In the area around the mine and mill, I observed a series of stormwater drains and catchment basins (**Photos 1 & 2**). This collection system delivers industrial stormwater to wastewater treatment plant 002 (WWTP 002) for treatment. I inspected WWTP 002, which received all of the facility's wastewater flows at the time of the inspection. WWTP 002 discharges to Outfall 002 (**Photo 3**) under individual permit ID0000175. Outfall 002 is located near Tailings Pond #2, which has been closed and reclaimed.

**Photo 1 / P1050015** – Southerly view of a stormwater catchment basin near the mill

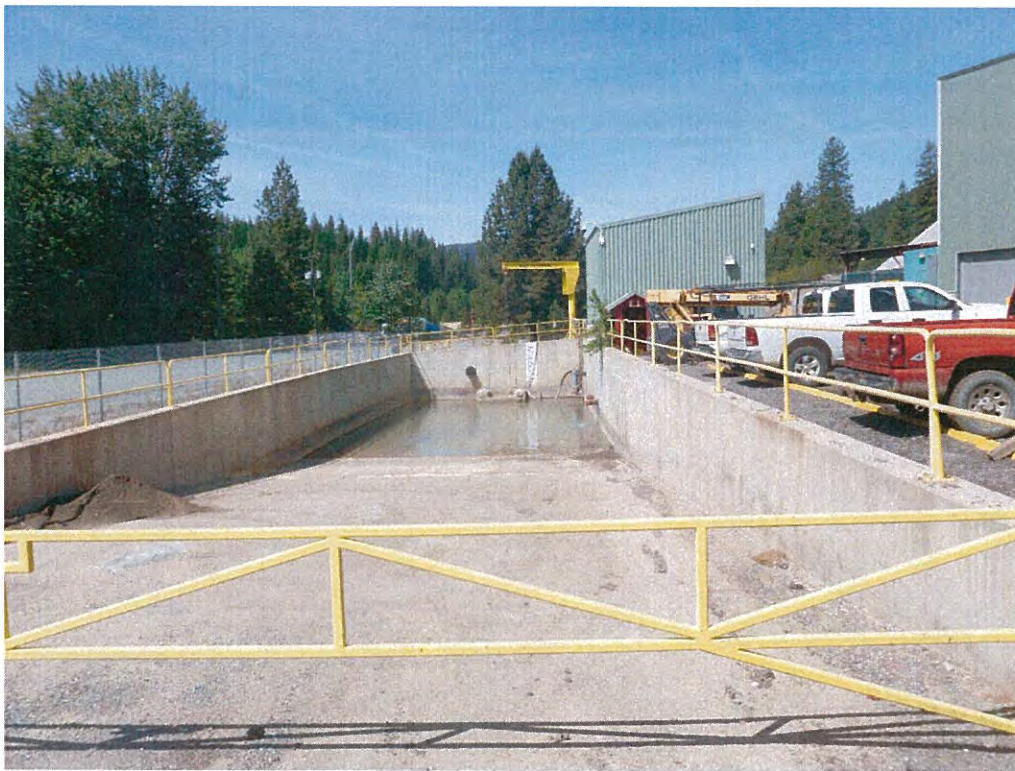
**Photo 2 / P1050020** – Westerly view of a stormwater catchment basin and sump pump located downgradient of the mill

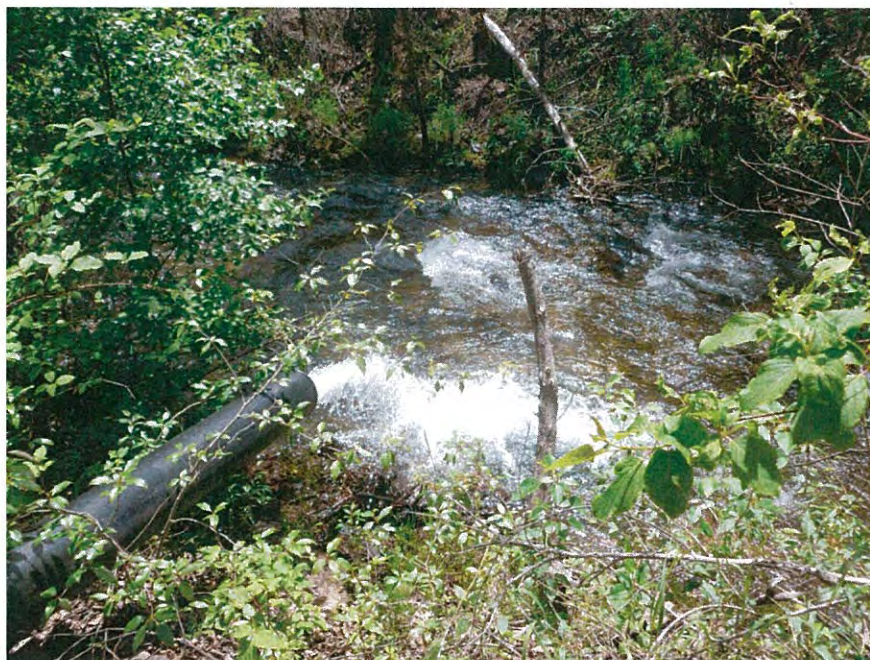
**Photo 3 / P1050032** – Discharge from wastewater treatment plant 002

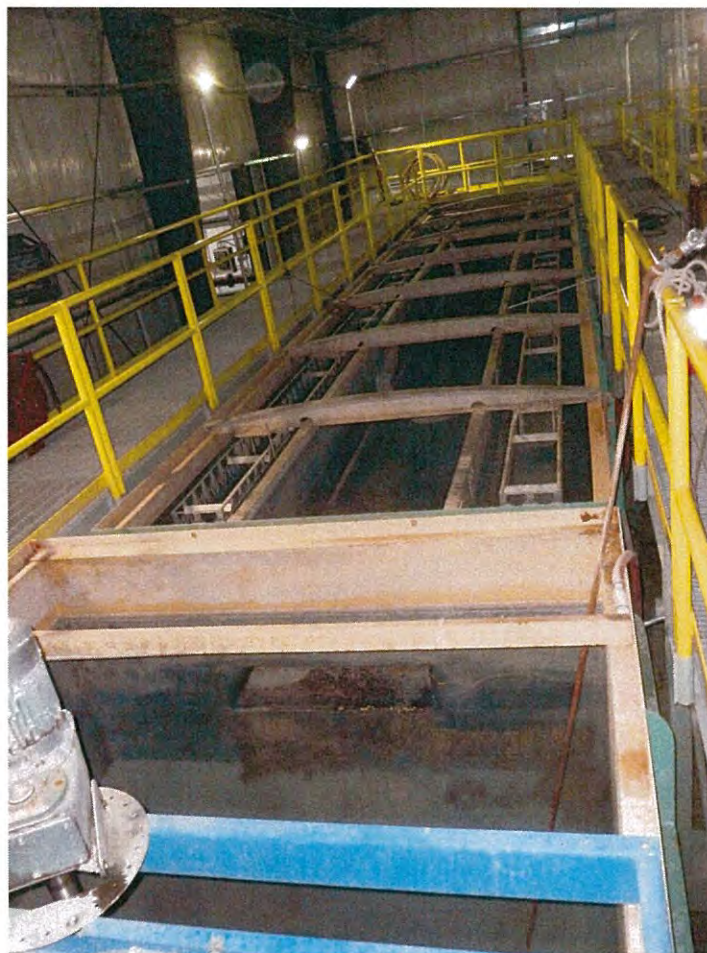
I inspected WWTP 003 (**Photo 4**), which was not in use at the time of the inspection. WWTP 003 discharges to Outfall 003 (**Photo 5**) under individual permit ID0000175. WWTP 003 and Outfall 003 are located near Tailings Pond #3, which no longer receives tailings and is in the process of closure. I also inspected Tailings Pond #1, which has been closed and reclaimed. I observed that Outfall 001 (**Photo 6**) has been capped to prevent discharge. All tailings are collected in lined Tailings Pond #4 (**Photo 7**).

**Photo 4 / P1050022** – Clarifier at wastewater treatment plant 003

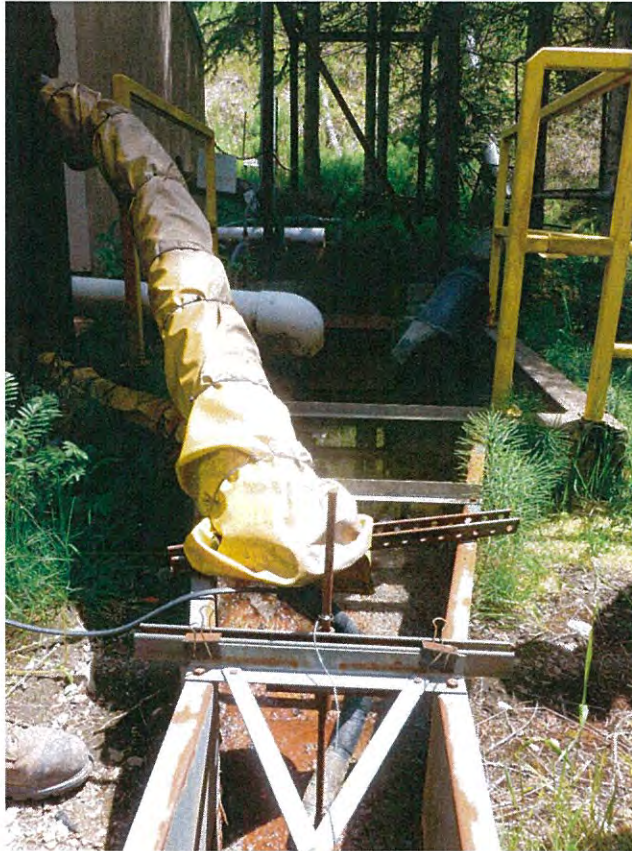
**Photo 5 / P1050023** – Easterly view of the discharge flume from wastewater treatment plant 003

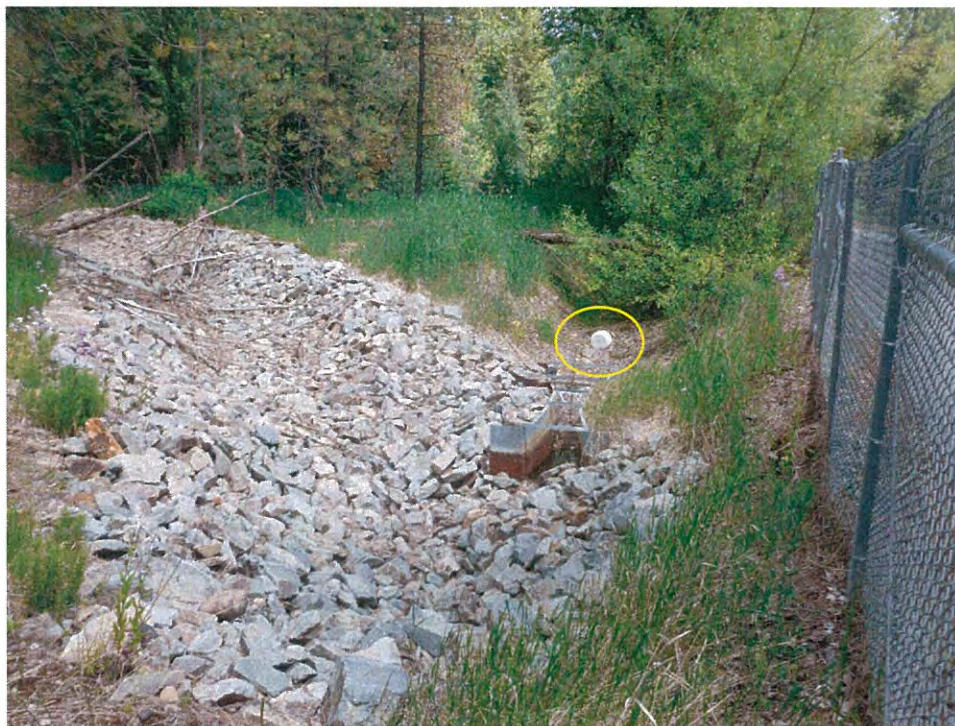
**Photo 6 / P1050033** – Northeasterly view of capped discharge pipe (circled) at decommissioned Tailings Pond 1

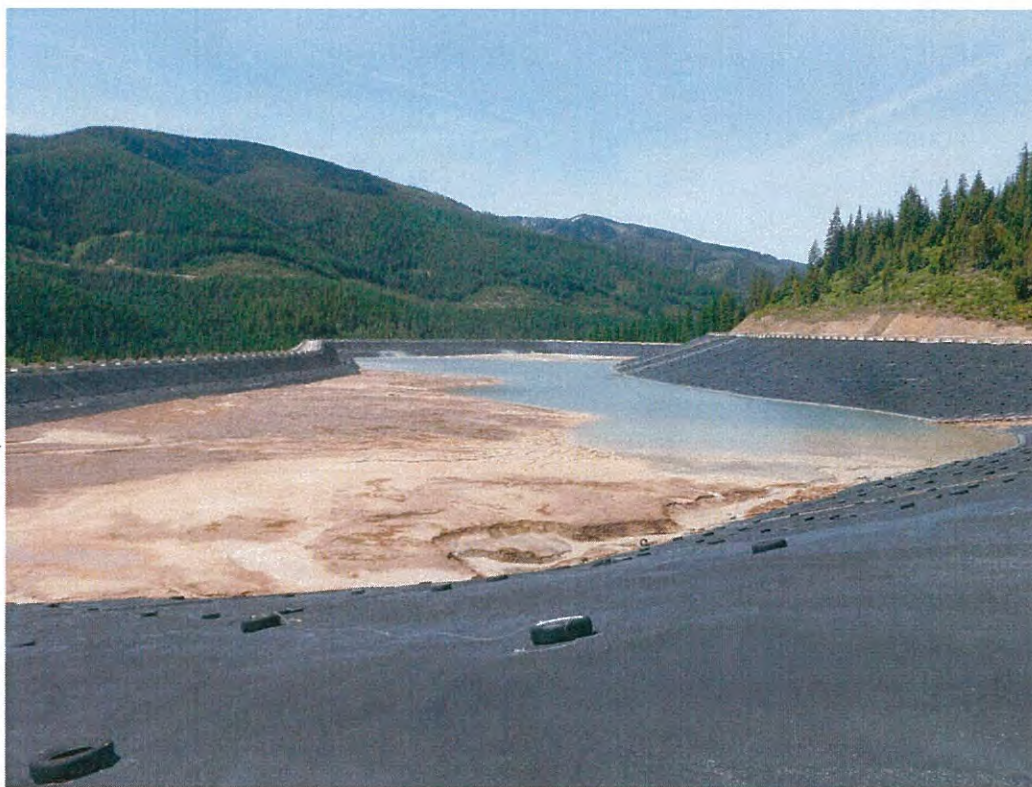
**Photo 7 / P1050021** – Southwesterly view of tailings pond 4

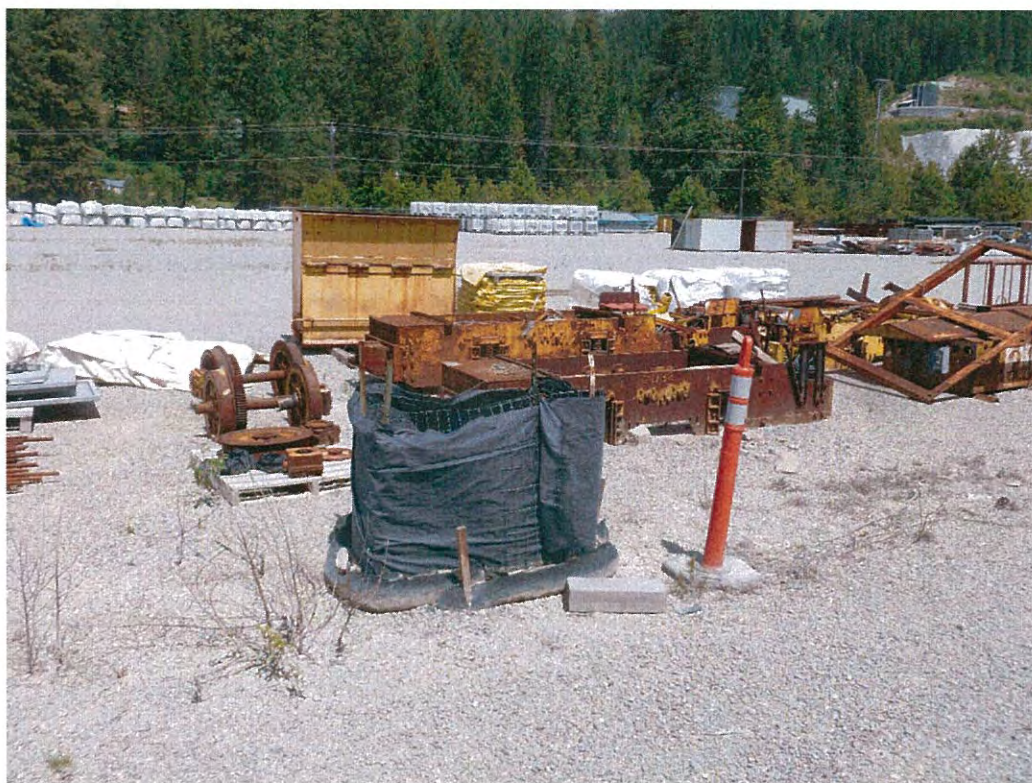
I also inspected eight potential stormwater outfalls that the facility has identified under MSGP IDR053139. Mr. Boylan and Mr. Thomas said that the facility inspects all eight potential outfalls for MSGP compliance, but Stormwater Outfall 001 (**Photo 8**) is the only location where industrial stormwater discharges are periodically observed. Receiving waters associated with the potential stormwater outfalls include the South Fork Coeur d'Alene River, Little North Fork of South Fork Coeur d'Alene River, Harris Creek, Hunter Creek and Daisy Creek. The South Fork Coeur d'Alene River is identified as the only receiving water associated with the three outfalls under individual permit ID0000175.

**Photo 8 / P1050027** – Northerly view of the storm drain upstream of stormwater outfall 001
